# The Uniform Building Inspection Report™ Condensed

**Single Family Residence:**  
432 West Bridge St., Las Vegas, NV

**Inspection Date:**  
7/1/2006, 9:00:00 AM

**Inspection Company:**  
Supreme Inspection Services  
P.O. Box 20826,  
Las Vegas, NV 89112  
702-450-7234

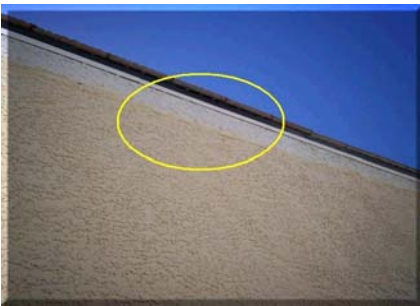
Photo: 1380 (1)

[P] 1380: Typical non-structural stucco (or exterior insulating finish system (EIFS)) cracks noted. Any cracks may allow water to enter the wall cavity. Recommend caulking of cracks to eliminate water intrusion. Correction or modification decreases the probability of excessive deterioration.  
See series 1380 photo(s)

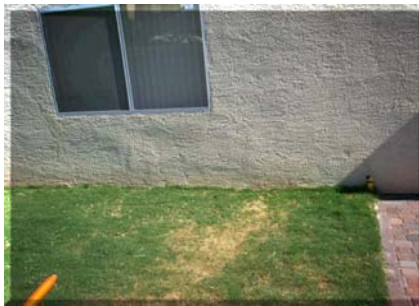
Photo: 1420 (1)

[D] 1420: Stucco weep screed blocked with dirt or concrete. Remove dirt to provide at least 4" of clearance if possible. If stucco goes to the ground, keep area dry and monitor stucco for water infiltration problems. Noted at the rear of the building. Significant component damage and/or ongoing damage apparent. Corrections advised.  
See series 1420 photo(s)

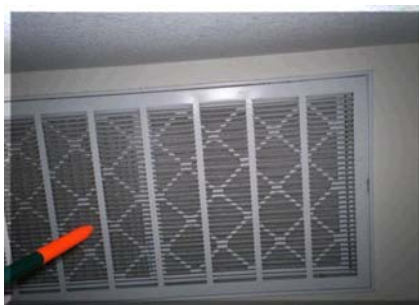
Photo: 2250.01 (1)

[E] [D] 2250.01: Filter(s) dirty at return duct for heating & air-conditioner unit(s).  
Replace all filters now if they are the disposable type. If the filters are the reuseable type, they should be cleaned and re-installed. Replace or service filters regularly following the manufacturers time-table and procedures. Repair, alteration or replacement usually improves the efficiency of the component or system.  
See series 2250.01 photo(s)

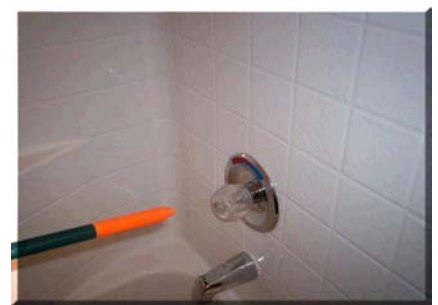
Photo: 4550.12 (1)

[F] 4550.12: Water valve faulty or otherwise amiss.  
Handle spins a full 360 degrees and has no positive bump-stop.  
Failure of a system or component. The system or component fails to

operate or to operate properly.  
See series 4550.12 photo(s)

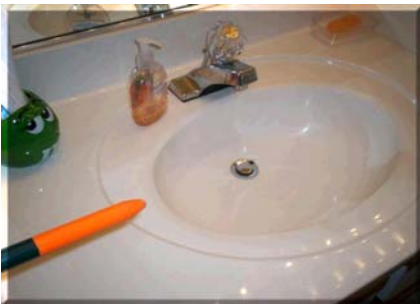
Photo: 4680 (1)

[E] [N] 4680: Fixture drain slow or clogged.  
Repair, alteration or replacement usually improves the efficiency of the component or system. Noted in the hall bath.  
See series 4680 photo(s)

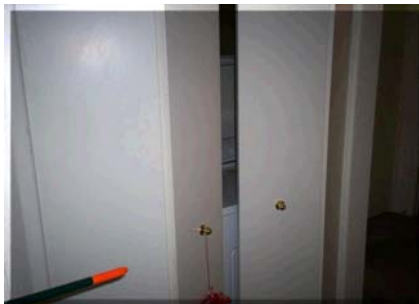
Photo: 4810.01 (1)

[E] 4810.01: Dryer make-up air insufficient.  
When the gas dryer is operating, be certain there is plenty of air available. This makeup air is replacement air for the air that is exhausted to the exterior. Repair, alteration or replacement usually improves the efficiency of the component or system.  
See series 4810.01 photo(s)

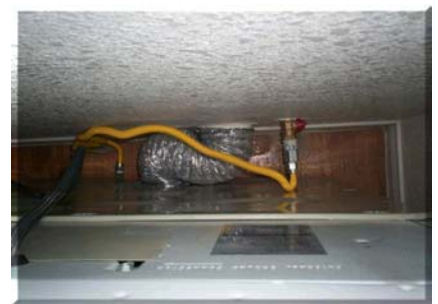
Photo: 4810.21 (1)

[U] 4810.21: Dryer vent improper.  
Gas dryer vents should be installed with a flexible metal vent not the plastic or aluminum venting material. Modification or addition is generally considered an upgrade which may improve safety or efficiency.  
See series 4810.21 photo(s)

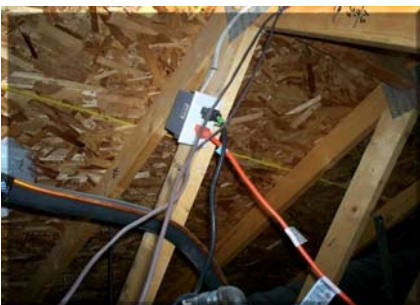
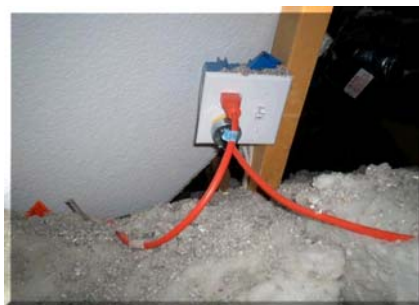
[R] 5470: Electrical additions/modifications noted.  
Ceiling fan(s) are connected by extension cords to the heating/service outlet(s) located in the attic. Noted for all three ceiling fans. It is recommended that the finding and all associated components be reviewed and corrected as needed, by a qualified licensed contractor.  
See series 5470 photo(s)

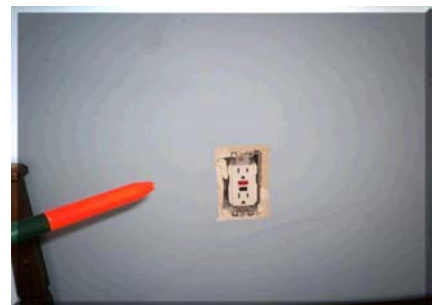
Photo: 5640 (1)

[F] 5640: Face or cover plate needed.  
This situation, problem has the potential of a electrical contact hazard. Correction by a qualified repair person is advised. Noted in the garage. Failure of a system or component. The system or component fails to operate or to operate properly.  
See series 5640 photo(s)

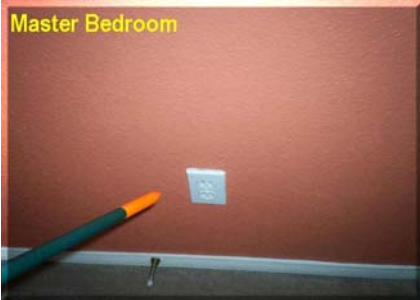
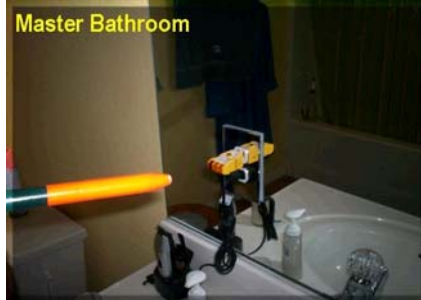
[D] [C] 5660.20: Receptacle outlet not secure.  
Loose switches and outlets, because of their heavy use, will soon develop loose connections and other problems. Noted in the master bath and master bedroom. Significant component damage and/or ongoing damage apparent. Corrections advised.  
See series 5660.20 photo(s)

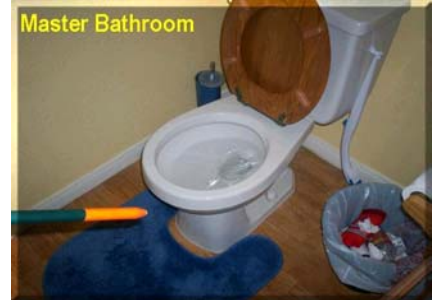
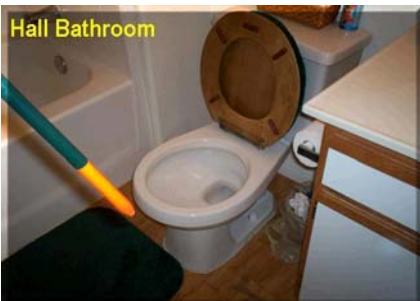
[R] 6200.01: Toilet bowl loose on floor. Noted in both bathrooms. Replace wax seal and then reset toilet to floor and caulk perimeter. The condition of the sub-floor (concrete or wood sheathing) is unknown. Check condition after pulling toilet and make repairs to damaged components. It is recommended that the finding and all associated components be reviewed and corrected as needed, by a qualified licensed contractor.  
See series 6200.01 photo(s)

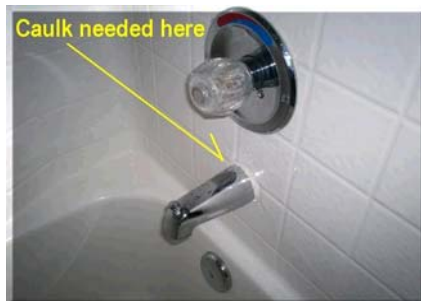
Photo: 6760.21 (1)

[P] 6760.21: Caulk spout at wall. Noted in the hall bath. Correction or modification decreases the probability of excessive deterioration.  
See series 6760.21 photo(s)

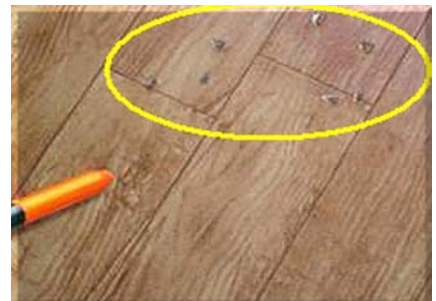
Photo: 7220.02 (1)

[A] 7220.02: "Vinyl" flooring damaged. Noted at the sliding glass door entrance.  
See series 7220.02 photo(s)

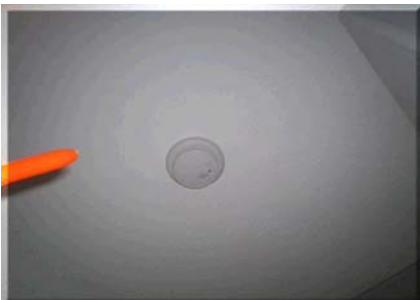
Photo: 7800.07 (1)

[Note] 7800.07: Smoke alarms tested. Service all units, following the manufacturers installation and maintenance instructions, or have a qualified repair person change batteries, and verify system operation on a regular basis. Replace units when they've reached the end of their service life, following manufactures installation/maintenance/replacement instructions.  
See series 7800.07 photo(s)

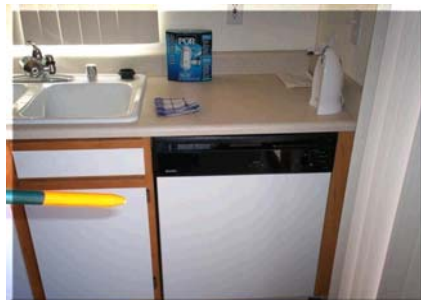
Photo: 8200.01 (1)

[R] 8200.01: Dishwasher maintenance and/or repairs needed. Dishwasher has no water for operating/test.. It is recommended that the finding and all associated components be reviewed and corrected as needed, by a qualified licensed contractor.  
See series 8200.01 photo(s)

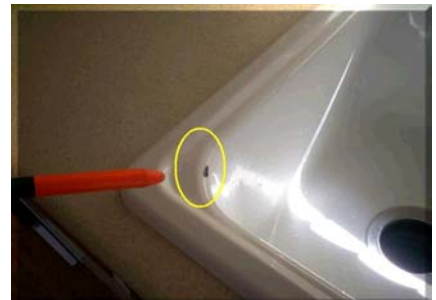
Photo: 8600 (1)

[A] 8600: Sink enamel or porcelain chipped. This problem is almost always considered cosmetic. Cracks and chips can often be masked with a dab of porcelain paint. Repair or alteration usually improves component appearance and should decrease deterioration.  
See series 8600 photo(s)

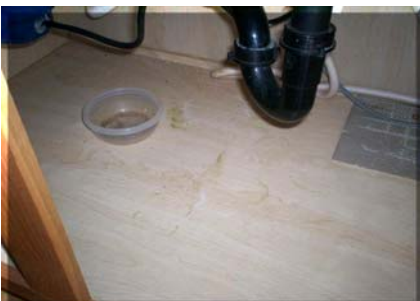
Photo: 8880.02 (1)

[M] 8880.02: Evidence of prior leaks (stains noted under sink). Noted under the kitchen sink. No active leak noted at this time. Monitor the situation on a regular basis. Corrections by a qualified licensed contractor, if and when necessary, are recommended.  
See series 8880.02 photo(s)
