The Uniform Building Inspection Report™

Single Family Residence:
432 West Bridge St., Las Vegas, NV

Inspection Date:
7/1/2006, 9:00:00 AM

Inspection Company:
Supreme Inspection Services
P.O. Box 20826,
Las Vegas, NV 89112
702-450-7234

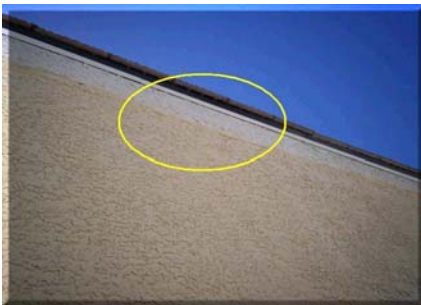
Photo: 1380 (1)

[P] 1380: Typical non-structural stucco (or exterior insulating finish system (EIFS)) cracks noted. Any cracks may allow water to enter the wall cavity. Recommend caulking of cracks to eliminate water intrusion. Correction or modification decreases the probability of excessive deterioration. See series 1380 photo(s)

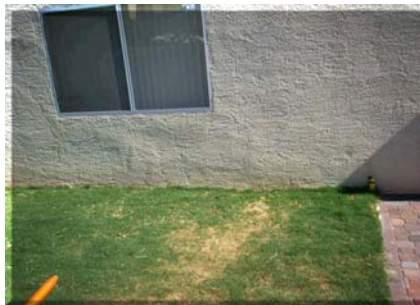
Photo: 1420 (1)

[D] 1420: Stucco weep screed blocked with dirt or concrete. Remove dirt to provide at least 4" of clearance if possible. If stucco goes to the ground, keep area dry and monitor stucco for water infiltration problems. Noted at the rear of the building. Significant component damage and/or ongoing damage apparent. Corrections advised. See series 1420 photo(s)

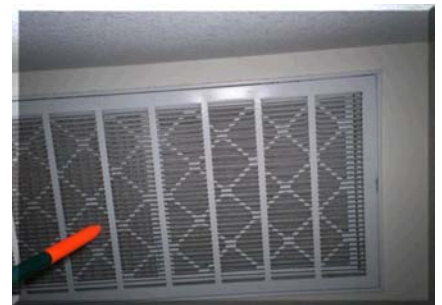
Photo: 2250.01 (1)

[E] [D] 2250.01: Filter(s) dirty at return duct for heating & air-conditioner unit(s).

Replace all filters now if they are the disposable type. If the filters are the reuseable type, they should be cleaned and re-installed. Replace or service filters regularly following the manufacturers time-table and

procedures. Repair, alteration or replacement usually improves the efficiency of the component or system. See series 2250.01 photo(s)

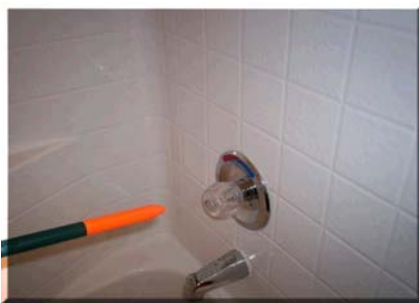
Photo: 4550.12 (1)

[F] 4550.12: Water valve faulty or otherwise amiss. Handle spins a full 360 degrees and has no positive bump-stop. Failure of a system or component. The system or component fails to operate or to operate properly.

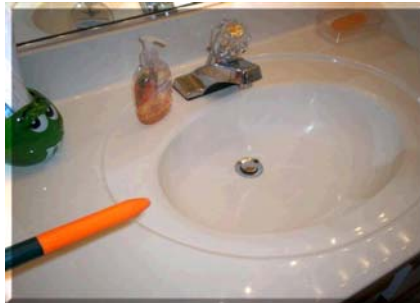
Photo: 4680 (1)

[E] [N] 4680: Fixture drain slow or clogged. Repair, alteration or replacement usually improves the efficiency of the component or system. Noted in the hall bath.

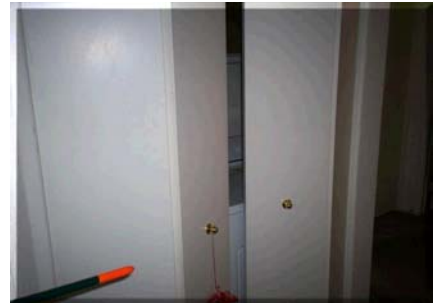
Photo: 4810.01 (1)

[E] 4810.01: Dryer make-up air insufficient. When the gas dryer is operating, be certain there is plenty of air available. This makeup air is replacement air for the air that is exhausted to the exterior. Repair, alteration or replacement usually improves the efficiency of the component or system. See series 4810.01 photo(s)

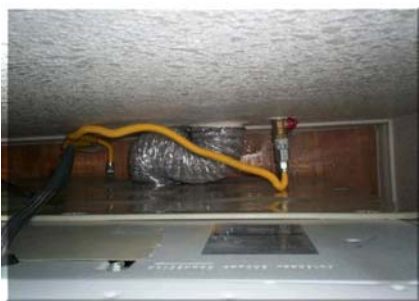
Photo: 4810.21 (1)

[U] 4810.21: Dryer vent improper.

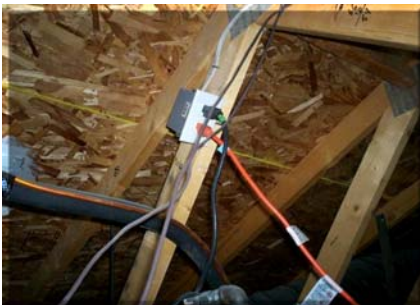
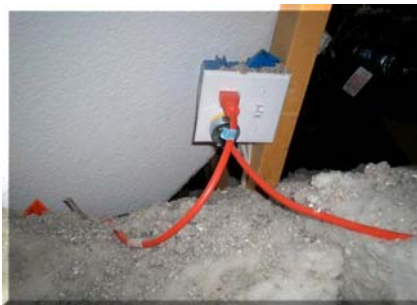
Photo: 5470 (1)

[R] 5470: Electrical additions/modifications noted. Ceiling fan(s) are connected by extension cords to the heating/service outlet(s) located in the attic. Noted for all three ceiling fans. It is recommended

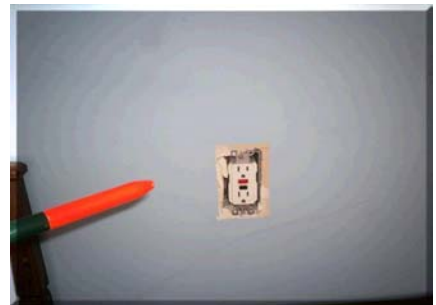
Photo: 5640 (1)

This situation, problem has the potential of a electrical contact hazard. Correction by a qualified repair person is advised. Noted in the garage.

Failure of a system or component. The system or component fails to operate or to operate properly. See series 5640 photo(s)

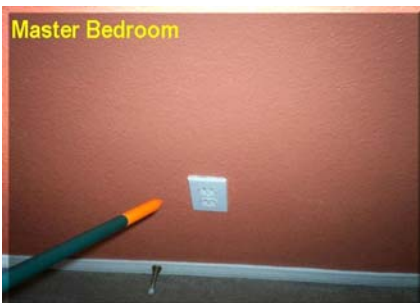
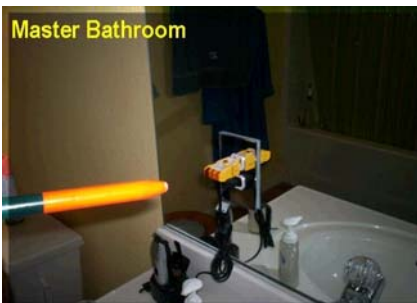
Photo: 5660.20 (1)

[D] [C] 5660.20: Receptacle outlet not secure. Loose switches and outlets, because of their heavy use, will soon develop loose connections and other problems. Noted in the master bath and master bedroom. Significant component damage and/or ongoing damage apparent. Corrections advised. See series 5660.20 photo(s)

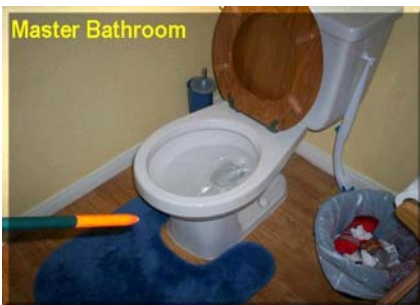
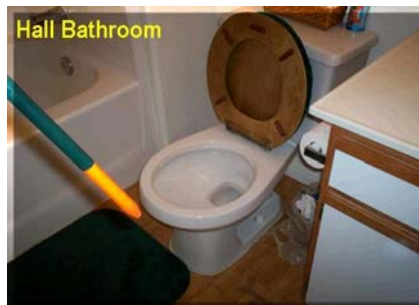
Photo: 6200.01 (1)

[R] 6200.01: Toilet bowl loose on floor. Noted in both bathrooms.

Replace wax seal and then reset toilet to floor and caulk perimeter. The condition of the sub-floor (concrete or wood sheathing) is unknown. Check condition after pulling toilet and make repairs to damaged components. It is recommended that the finding and all associated components be reviewed

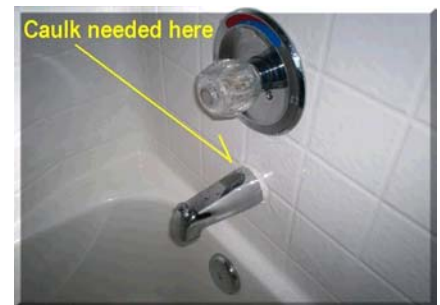
Photo: 6760.21 (1)

[P] 6760.21: Caulk spout at wall. Noted in the hall bath. Correction or modification decreases the probability of excessive deterioration. See series 6760.21 photo(s)

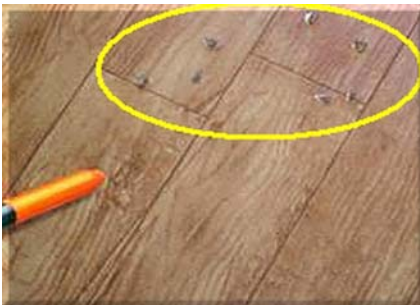
Photo: 7220.02 (1)

[A] 7220.02: "Vinyl" flooring damaged.
Noted at the sliding glass door entrance.

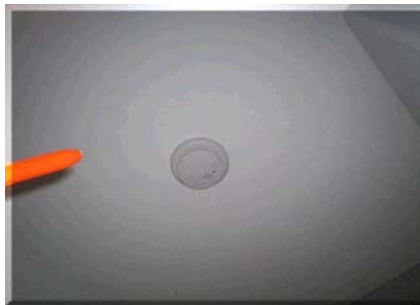
Photo: 7800.07 (1)

[Note] 7800.07: Smoke alarms tested.
Service all units, following the manufacturers installation and maintenance instructions, or have a qualified repair person change batteries, and verify system operation on a regular basis. Replace units when they've reached the end of their service life, following manufactures installation/maintenance/replacement instructions.
See series 7800.07 photo(s)

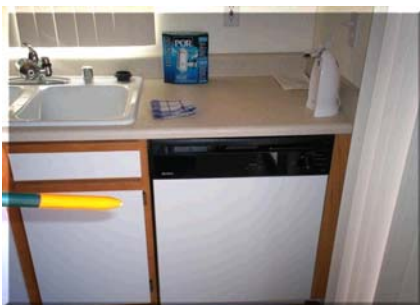
Photo: 8200.01 (1)

[R] 8200.01: Dishwasher maintenance and/or repairs needed.
Dishwasher has no water for operating/test.. It is recommended that the finding and all associated components be reviewed and corrected as needed, by a qualified licensed contractor.

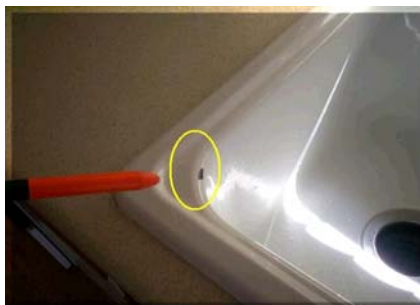
Photo: 8600 (1)

[A] 8600: Sink enamel or porcelain chipped.
This problem is almost always considered cosmetic. Cracks and chips can often be masked with a dab of porcelain paint. Repair or alteration usually improves component appearance and should decrease deterioration.

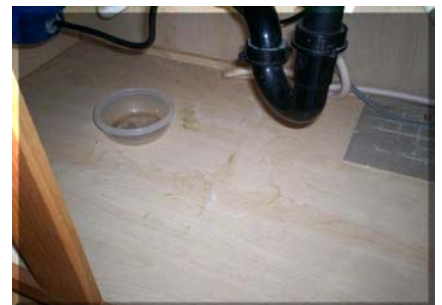
Photo: 8880.02 (1)

[M] 8880.02: Evidence of prior leaks (stains noted under sink).

Noted under the kitchen sink. No active leak noted at this time. Monitor the situation on a regular basis. Corrections by a qualified licensed contractor, if and when necessary, are recommended.
